**Agricultural Engineering**

## IMPACT OF THERMAL BRIDGES ON THERMAL PROPERTIES OF THE NEW-TYPE PIGGERIES STRUCTURES

The objective of this paper is a qualitative and quantitative characterization of thermal bridges on the walls of a new -built piggery. In the first step, the proposed methodology involves an infrared camera employed to locate the thermal bridges on the walls. Experimental part of the paper consists of thermograms of the envelope with their interpretation. The next step is calculation of the thermal characteristics and heat losses caused by thermal bridges.

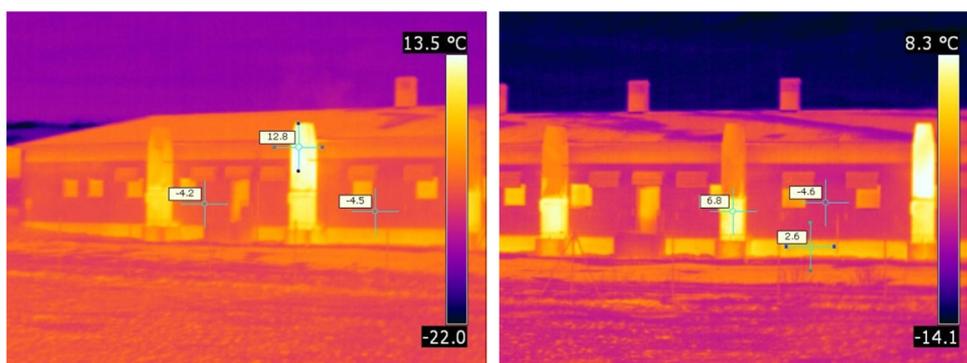
Figure 1. South façade of piggery (part 1)      Figure 2. South façade of piggery (part 2)

Surface temperature of the brick wall is about  $-5.2^{\circ}\text{C}$ . As we can see in Figure 1 there is increased heat flow in socle parts (height 0.7 m) of the structure because socle and foundations are from uninsulated steel concrete and also flooring has no thermal insulation. A comparable problem with heat transfer over uninsulated foundations is presented in (Al-Anzi and Krarti, 2004). The warm water floor heating system without thermal insulation of flooring is an unsuitable solution for this structure. The average surface temperature of the socle is about  $0.5^{\circ}\text{C}$ . Significant detail there is steel concrete straining band of the wall. It is bearing structure with poor thermal insulation.

This layer (height 0.25 m) is placed under steel roof frame. Next thermal bridge related to the straining band is the bearing roof frame with external brickwork with insufficient thermal resistance. This thermal defect of the envelope caused by the bearing steel frames is similar to the results of (Höglund and Burstrand, 1998; Juárez et al., 2012; Al-Sanea and Zedan, 2012). How we can see that there is a layer in the top part of the wall (height 0.5 m), where apparent heat fluxes are visible. The average surface temperature of the brickwork is about  $-4.9^{\circ}\text{C}$ . The next problematic detail there are the door and window frames mainly at the pass between the frame and the wall. Probably it is caused by poor thermal parameters of the frames and unsuitable construction design of this detail. The surface temperature at the door frame is about  $1.2^{\circ}\text{C}$ . The surface temperature at the window frame is about  $0.8^{\circ}\text{C}$ . A similar case study of thermal bridges by window framework is presented in (Ben-Nakhi, 2002; Cappelletti et al., 2011). Thermal bridges caused by steel reinforcement of the wall are presented in (Fukuyo, 2003). Figure 2 and figure 3 represent the second part and the third part of the south façade of the piggery. As we can see the same situation is with the existence of thermal bridges in critical structure details. Figure 4 and Figure 5 represent a west façade (gable wall). Most problematic there is the straining band again. The surface temperature at the straining band is about  $-5.2^{\circ}\text{C}$ . A socle part of the wall has only 0.2 m height but has not thermal insulation. Figure 6 and figure 7 (east façade of piggery) and figure 8 (north façade of piggery) represent thermograms with similar situation which confirm unsuitable solution of structure details.
